LPC# 2010300031- Winnebago  
Rexnord, Inc., Rockford Products Plt. #3  
ILD005212097  
Superfund/HRS  
Volume 2 of 2

# **CERCLA**

## **Screening Site Inspection Report**

**Illinois Environmental  
Protection Agency**  
P.O. Box 19276  
Springfield, IL 62794-9276

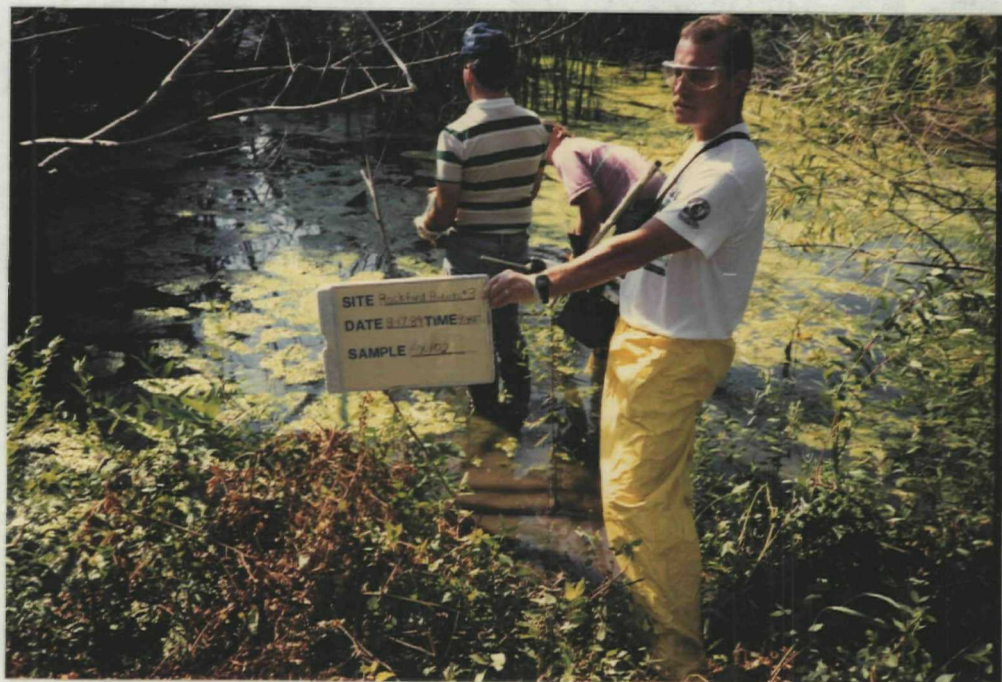
Surface Water Sampling Procedures. Sample designation S101 was collected from the east side of the seepage pit approximately 25 feet from the shore line. A Lab-Line Instruments, Inc., Water Sampler with an attached nylon cord was used to collect the sample. The weighted water sampler was thrown from the edge of the shore line to a designated area in the seepage where it was allowed to sink prior to sample collection. Once the bottle was filled, it was retrieved by the nylon cord, and the process was repeated until all sample bottles were filled. After sample collection, the bottles were dried,
